CONDITION REPORT

Dielsdorf, ZH
19.01.2024

Gerhard Richter
Studie zu 451 (451-B)
1979
Oil on Fabric
Frame: 185 × 155 × 5.9 cm
Painting: 180.4 × 150.6 × 4.2 cm
Signature: Signed on reverse „Studie zu 451 / (Richter, 1979)“

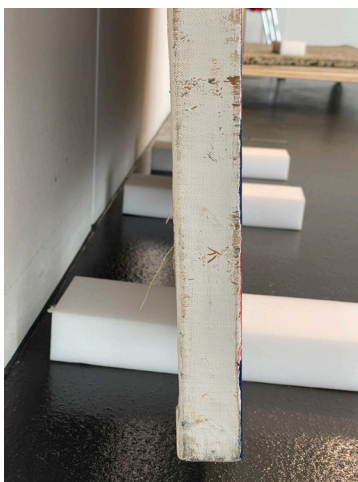
As described under the „Technique“ section, the tacking margins are showing distinct traces of wear. Some abrasions, losses, and adhered materials are visible. These were likely to have been caused while it was at the artist's studio as these are usually not present in a warehouse.

Left Side of tacking margin with adhering dirt

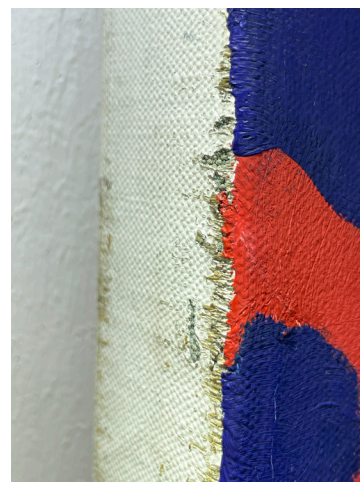
The painting support is fixed on the reverse of the stretcher frame with staples. The stretcher frame facing backwards has a typical rim (as the front of a regular stretcher frame normally should). Therefore, the outer edge is slightly protruding. Staple marks from a previous stretching are visible along the tacking margin. These marks are clearly visible but underneath the second priming layer. Therefore, most of the hole marks are filled with the second priming layer. As the second priming layer is underneath the paint layer, it must have happened before the final painting layers were applied. However, it is unclear when the artwork was re-stretched and the tacking margins were treated. Some abrasions, losses, and adhered materials are visible on the tacking margins, especially on the left side. These were probably caused while it was at the artist's studio, as these are usually not present in a warehouse and it seems the adhering material got embedded in the paint while it was still wet. The final paint layer covers some of the losses to the priming layers.

Detail_Paint in Losses on Priming Layer on
Tacking Margin

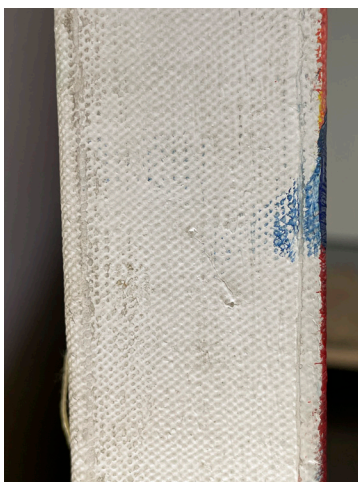
Detail_Marks from a former mounting

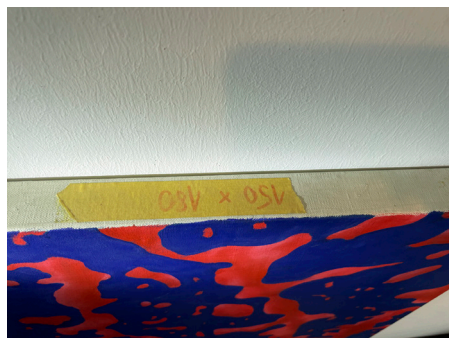
A tape with a handwritten note on the format size is attached at the upper edge of the tacking margin.

Label at upper edge of tacking margin

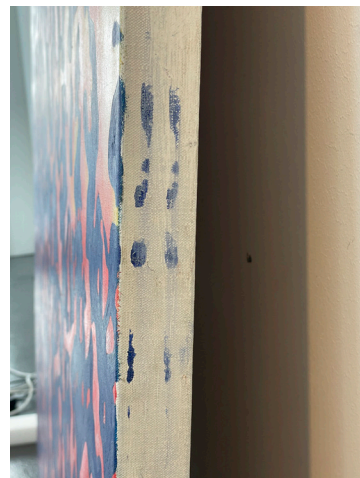
Paint Marks_Right Tacking Margin

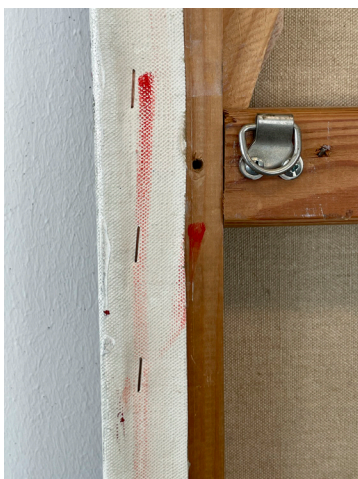
Paint Marks on Reverse

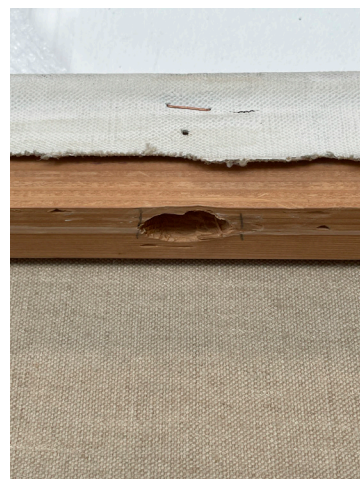
The fabric is mounted on a wooden stretcher frame with two vertical and two horizontal crossbars. The stretcher frame is custom made and assembled from two stretcher frames glued together on their backs. The assembling was done professionally but there is evidence of it been done by hand. It is likely that the stretcher frames were put together in the artist's studio in order to enlarge the depth of the artwork. The unique production of this stretcher frame refers to the creative and precise working process of Gerhard Richter. Paint marks which correspond to the paint on the front are also visible on the stretcher frame. There is a recess in the stretcher on the upper edge where the work was previously hung with L-hooks.

Old Hanging System in Stretcher

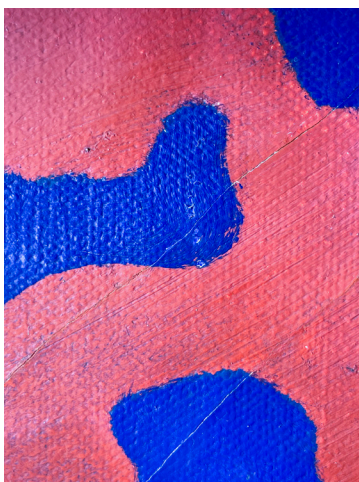
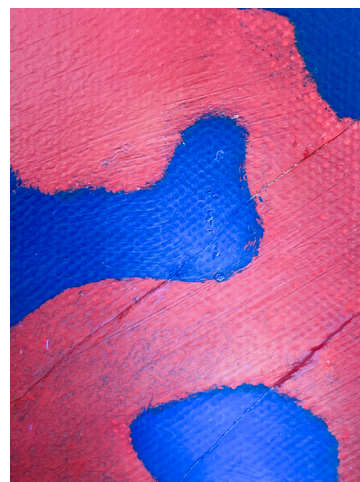
Under ultraviolet light, small retouches within the cracks are visible. Partially, the retouching colour has tinted the fibres of the support and became visible on the reverse. The only other retouches are small inpaints in the corners of the artwork. All retouches are well integrated and are hardly detectable under regular light condition.

Detail_Crack_With Retouch_1_Regular Light

Detail_Crack_With Retouch_1_UV

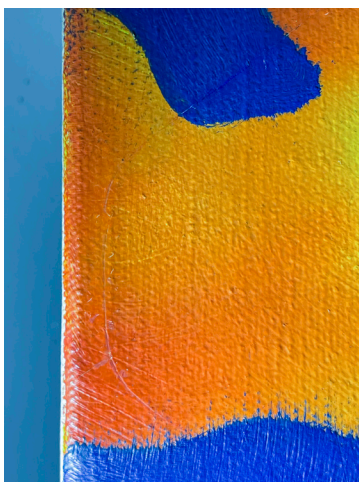
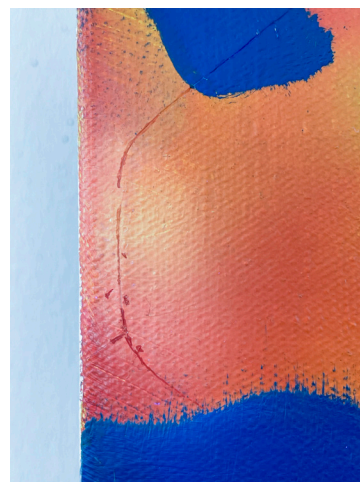
Detail_Retouched Crack_2_Regular Light

Detail_Retouched Crack_2_UV ray

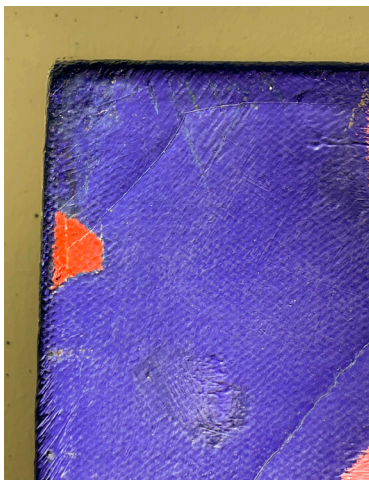
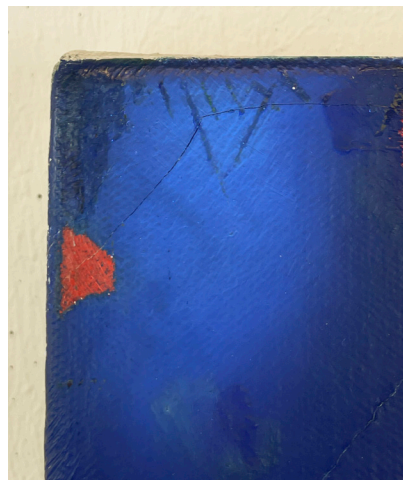
Detail_Upper Left Corner_Side Ray

Detail_Upper Left Corner_UV

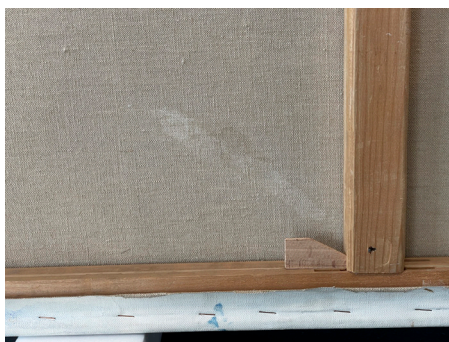
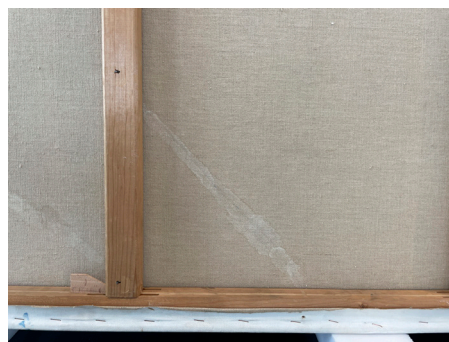
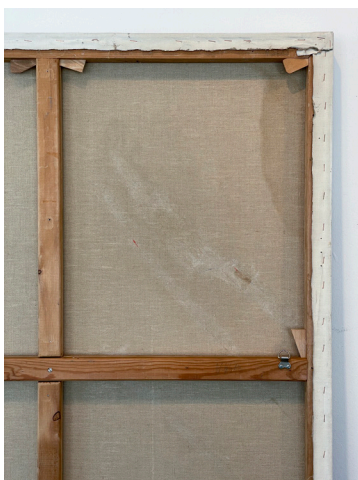
Some of the cracks have been treated in the past with glue from the reverse. The glue seeped through the cracks in a few areas and resurfaced in the front. This is only visible under ultraviolet light.

Restoration of Cracks_Reverse_1

Restoration of Cracks_Reverse_2

Restoration of Cracks_Reverse_3

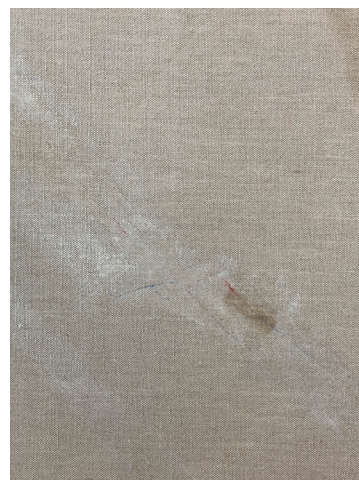
Detail_Visible Retouche from Reverse
