CONDITION REPORT

Dielsdorf, ZH
19.01.2024

Gerhard Richter
Studie zu 451 (451-B)
1979
Oil on Fabric
Frame: 185 × 155 × 5.9 cm
Painting: 180.4 × 150.6 × 4.2 cm
Signature: Signed on reverse „Studie zu 451 / (Richter, 1979)“

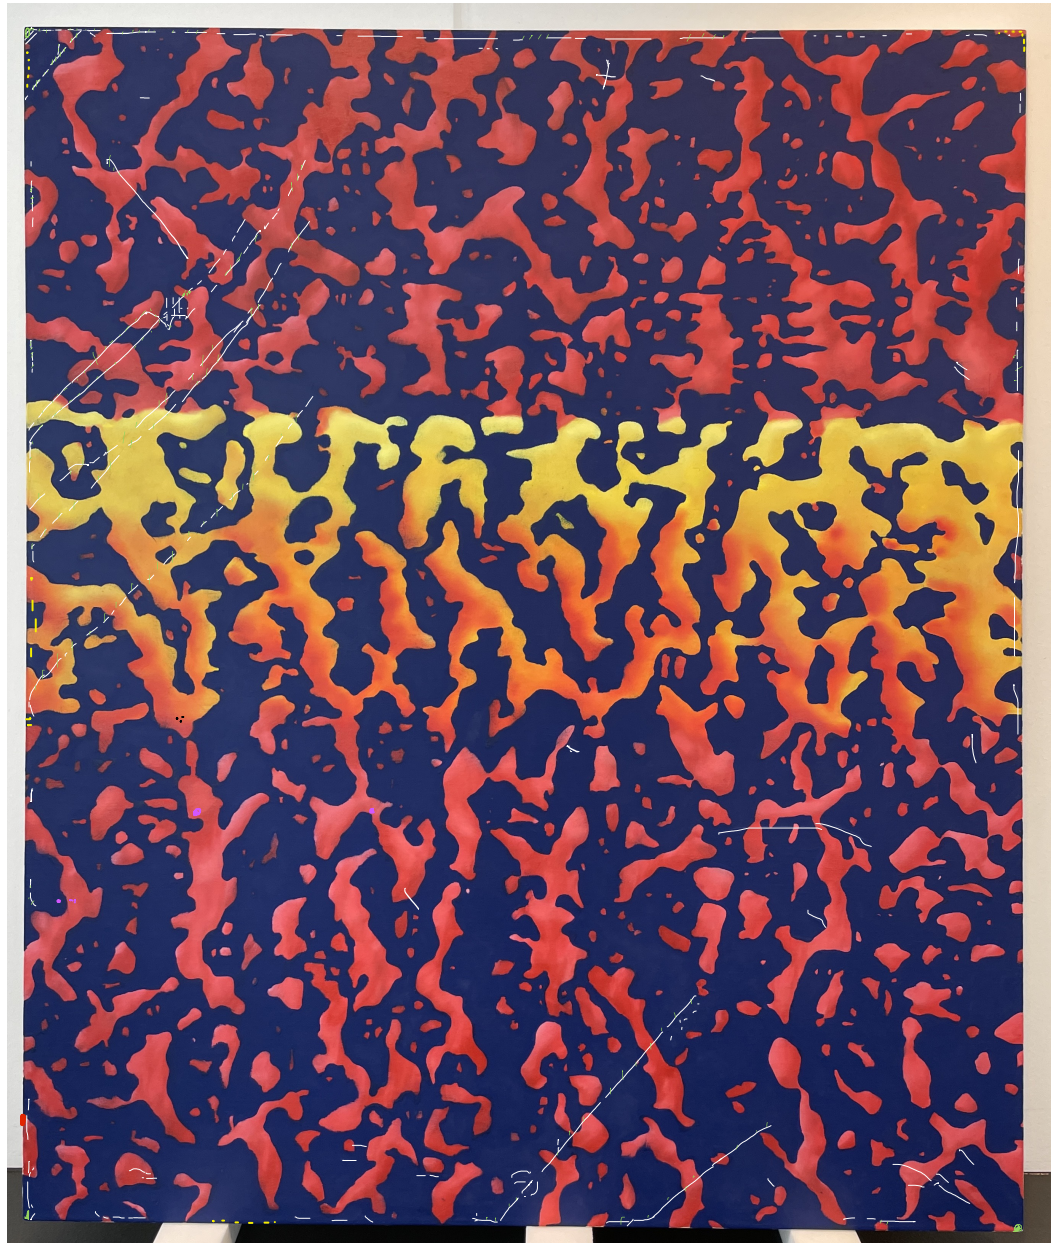
Distinct cracks are visible along the upper left and lower right quadrants of the artwork as well as along the edges of the painting. From the reverse the cracks are marking linear deformations in the painting's support.

Some of the cracks have been treated in the past with glue from the reverse. The glue seeped through the cracks in a few areas and resurfaced in the front. This is only visible under ultraviolet light.

Under ultraviolet light, small retouches within the cracks are visible. Partially, the retouching colour has tinted the fibres of the support and became visible on the reverse. The only other retouches are small inpaints in the corners of the artwork. All retouches are well integrated and are hardly detectable under regular light condition.

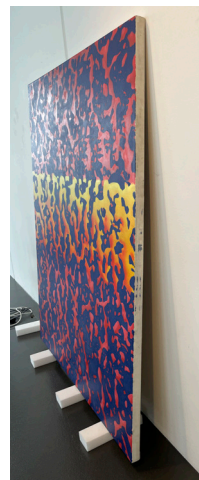
Right Side_Tacking Margin

As described under the „Technique“ section, the tacking margins are showing distinct traces of wear. Some abrasions, losses, and adhered materials are visible. These were likely to have been caused while it was at the artist's studio as these are usually not present in a warehouse.

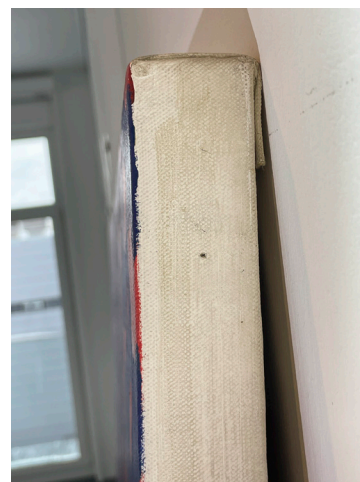
The fabric has an industrially applied priming layer which ends at the cut edges of the fabric. A second priming layer is present. This priming layer is visible on the tacking margins. It has a brighter colour than the industrially applied layer and exhibits brushstrokes.

Detail_Second Layer Primer on right tacking
margin

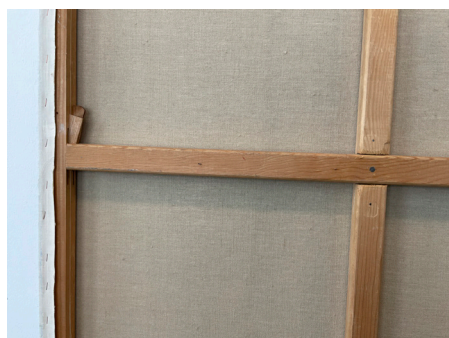
The fabric is mounted on a wooden stretcher frame with two vertical and two horizontal crossbars. The stretcher frame is custom made and assembled from two stretcher frames glued together on their backs. The assembling was done professionally but there is evidence of it been done by hand. It is likely that the stretcher frames were put together in the artist's studio in order to enlarge the depth of the artwork. The unique production of this stretcher frame refers to the creative and precise working process of Gerhard Richter. Paint marks which correspond to the paint on the front are also visible on the stretcher frame. There is a recess in the stretcher on the upper edge where the work was previously hung with L-hooks.

Details_Doubled stretcher frame

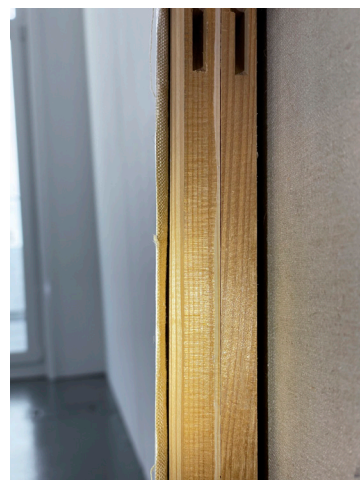
Detail of glued stretcher frame

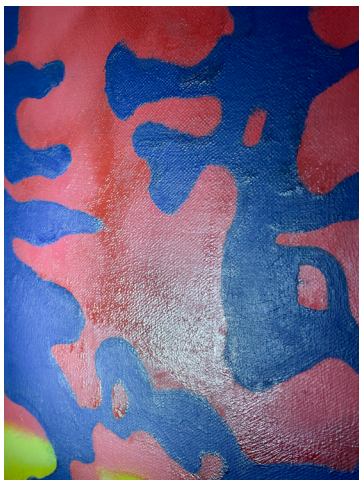
A difference in gloss is inherent to Gerhard Richter's paint application. The artwork appears to be unvarnished but an enrichment of the colour by using more binding medium is likely. A slight separation of the binding medium is visible in the blue. When examined with an ultraviolet light the outlines of the blue brushstrokes exhibit a brighter fluorescence, which indicates that some of the binder was washed out towards the edge when the paint was applied. Furthermore, in some areas of the blue whitish hazes are visible, which are likely to be in connection with the binding medium. The medium of the colours itself has not been analysed.

Detail Painting Technique_Differences
in Gloss_Reflecting Light

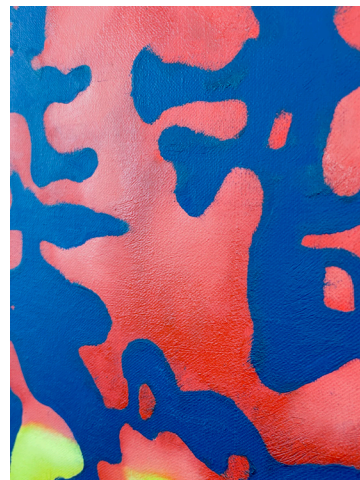
Detail Painting Technique_Differences in
Gloss_Regular Light

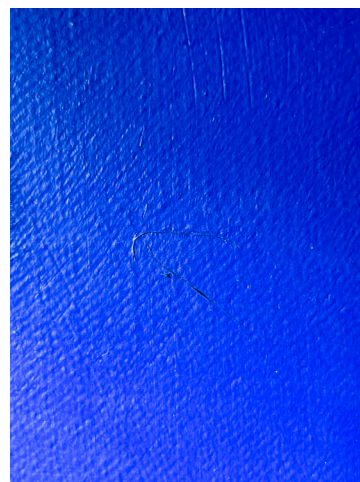
The red and yellow colours were the first layers of paint applied by the artist. These colour fields have a rather flat paint application with sharp and wide brushstrokes throughout. They were implemented in a fast manner. Richter applied the blue in a second step, which is thicker than the earlier applied layers. Clearly defined brushstrokes can be seen here, particularly along the colour boundaries, suggesting a concentrated working method with a commitment to sculpting the shapes. In many areas, the outer edge of the brushstrokes moved into the colour shapes and left distinct traces on the red and yellow areas. There are at least two different layers of blue paint applied. Embedded hairs of the brush, which was used by Richter are visible in all colour sections.

Detail_Painting Technique_Embedded Hairs of
Brush
